A Lipan Apache Mission

San Lorenzo de la Santa Cruz · 1762-1771

By Curtis D. Tunnell and W. W. Newcomb, Jr.

THE ARCHEOLOGICAL INVESTIGATION

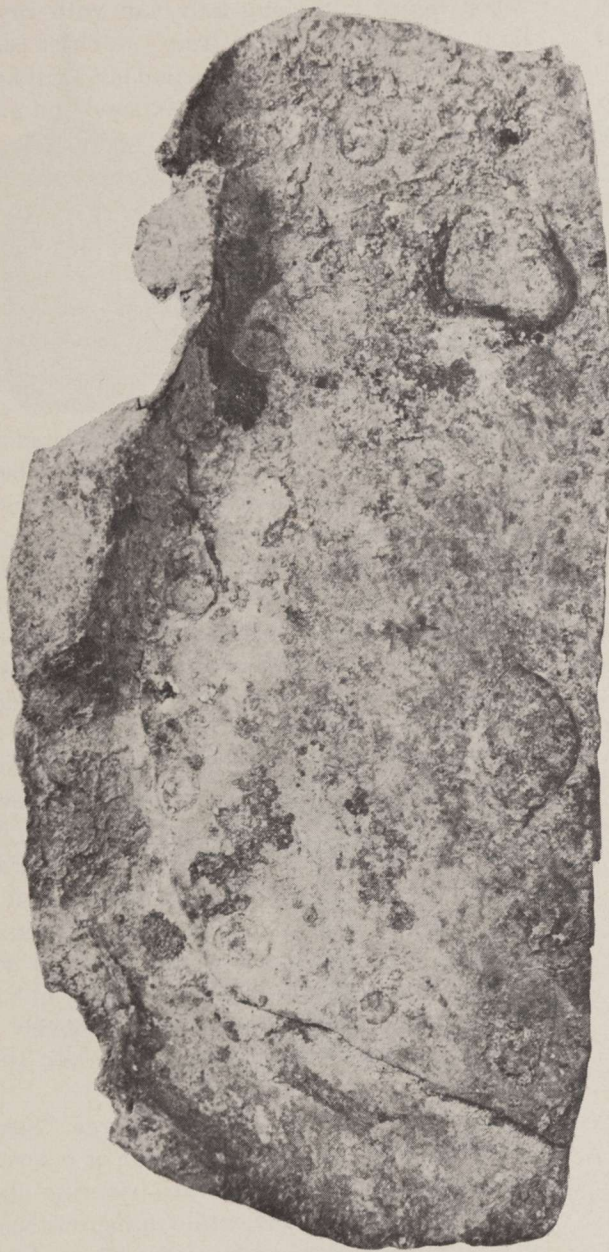
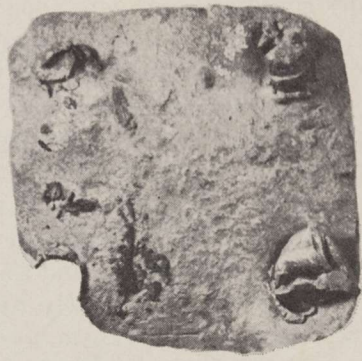
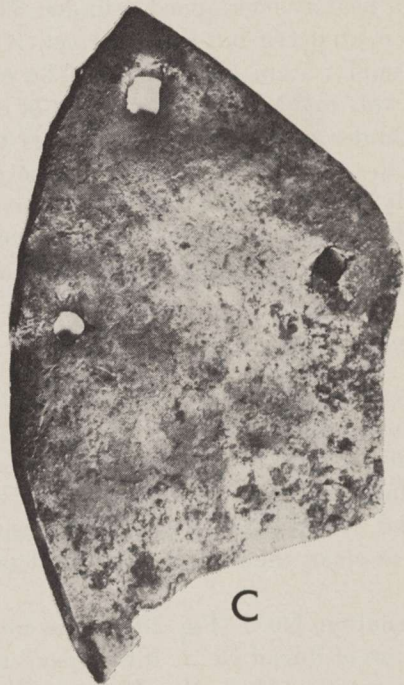
Fig. 28. Copper artifacts. A, heavily patched portion of pot bottom; B, patch with rivets in place; C, patch; D, strip.

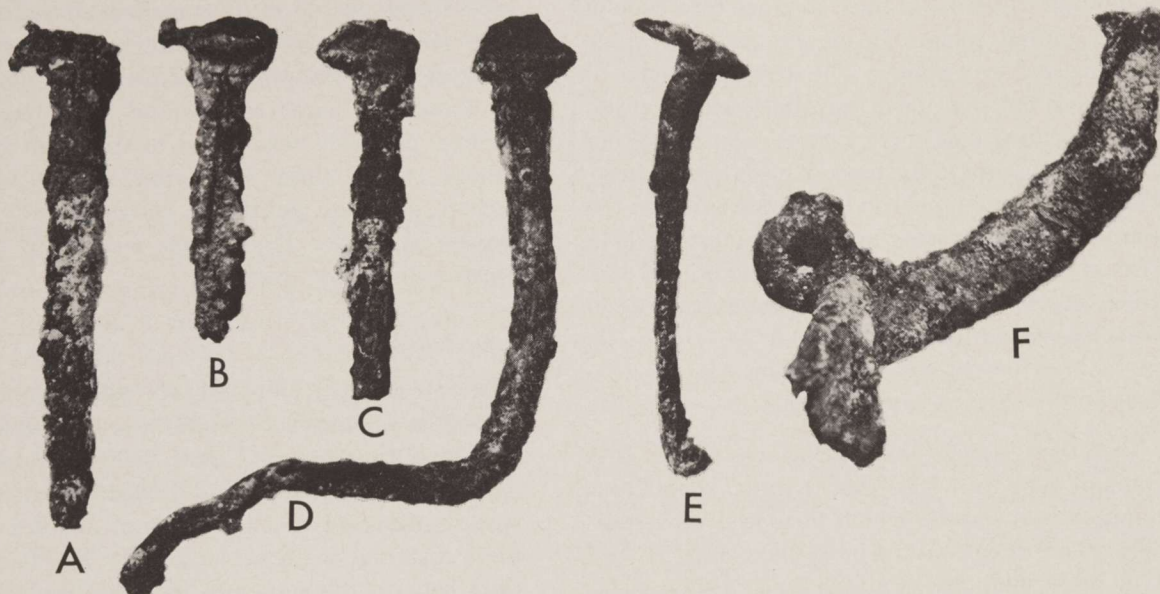
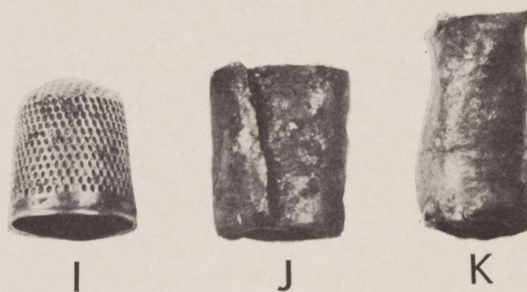
Fig. 31. Iron and copper artifacts. A-E, hand-forged iron nails; F, portion of mouth and side piece of iron bridle bit; G, brass button; H, two views of brass hawk bell; I, brass thimble; J, unidentified copper strip; K, unused rivet made from sheet copper.

A small brass thimble (Fig. 31, I) was found at the site. It has fine parallel striations on the inside. It has a dome-shaped upper end decorated with a grid of indentations 1 mm. square, a distinct shoulder, and straight sides decorated with diagonal rows of circular punctations 1 mm. in diameter. The punctations extend down to within 3 mm. of the lower edge. The exterior dimensions are: overall length, 1.8 cm.; length of walls, 1.5 cm.; width at top, 1.3 cm.; width at bottom, 1.7 cm.; wall thickness, 1 mm.

This tiny bell (Fig. 31, H) is made from two thin, sheet-brass hemispheres whose edges are soldered flush together forming a smooth joint around the center of the bell. Two faint parallel lines with ticked edges encircle each hemisphere about 1 mm. from the soldered joint and are spaced about 1 mm. apart. The lower half of the bell has two perforations, 4 mm. in diameter, spaced 9 mm. apart and connected by a narrow slit. The upper portion of the bell has a part of a thin brass suspension loop situated centrally. This loop is fashioned from a thin strip of brass 1 mm. wide which was inserted through a hole

in the hemisphere and fixed in place by a drop of silver colored solder. Inside the bell are some badly rusted iron pellets. The exterior surface of the hawk bell has faint parallel striations and ridges forming concentric circles extending from the median seam to the apex of each hemisphere. These striations appear to have resulted from the manufacturing process used in shaping the bell. This specimen is 1.7 cm. in diameter, 1.3 cm. thick (top to bottom), and it is made from sheet brass less than 1 mm. thick.

Only one copper alloy button was found. It is made of very thin (less than 1 mm.) sheet brass stamped into a mold which formed a very complex raised design on the outer face (Fig. 31, G). This brass shell was mounted on a wooden backing (partially preserved) by folding under the outer edge and thereby forming a flange about 2 mm. wide around the circumference of the rear

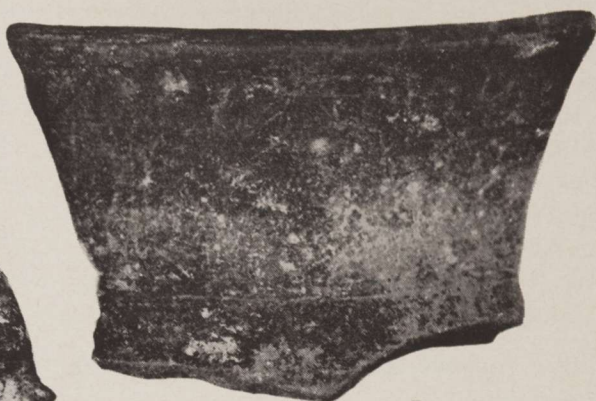
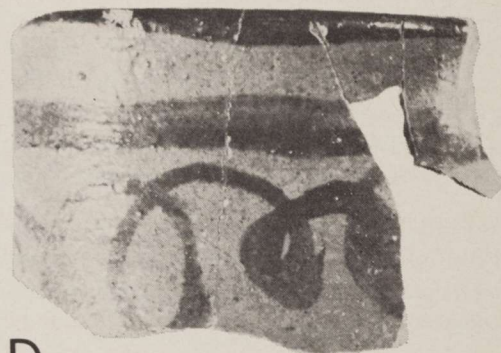
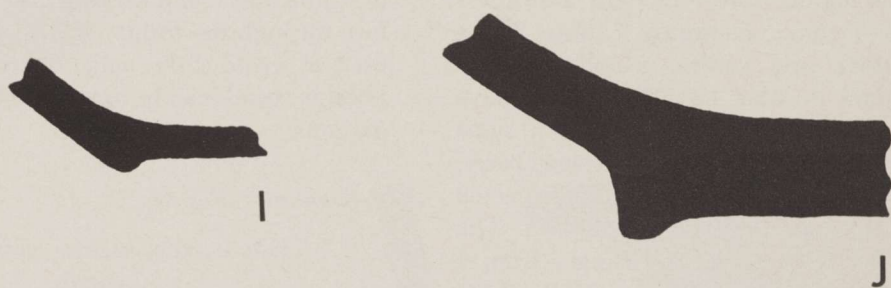
Fig. 42. Ceramics. A, amber lead-glazed plainware bowl rim; B, amber lead-glazed plainware jar rim; C, white salt-glazed stoneware sherd; D, clear lead-glazed brown painted jar rim; E, clear lead-glazed brown painted bowl rim.

LEAD-GLAZED, AMBER, PLAINWARE
(Fig. 42, A, B; Fig. 45), 1,988 sherds

(Fig. 42, C), 1 sherd

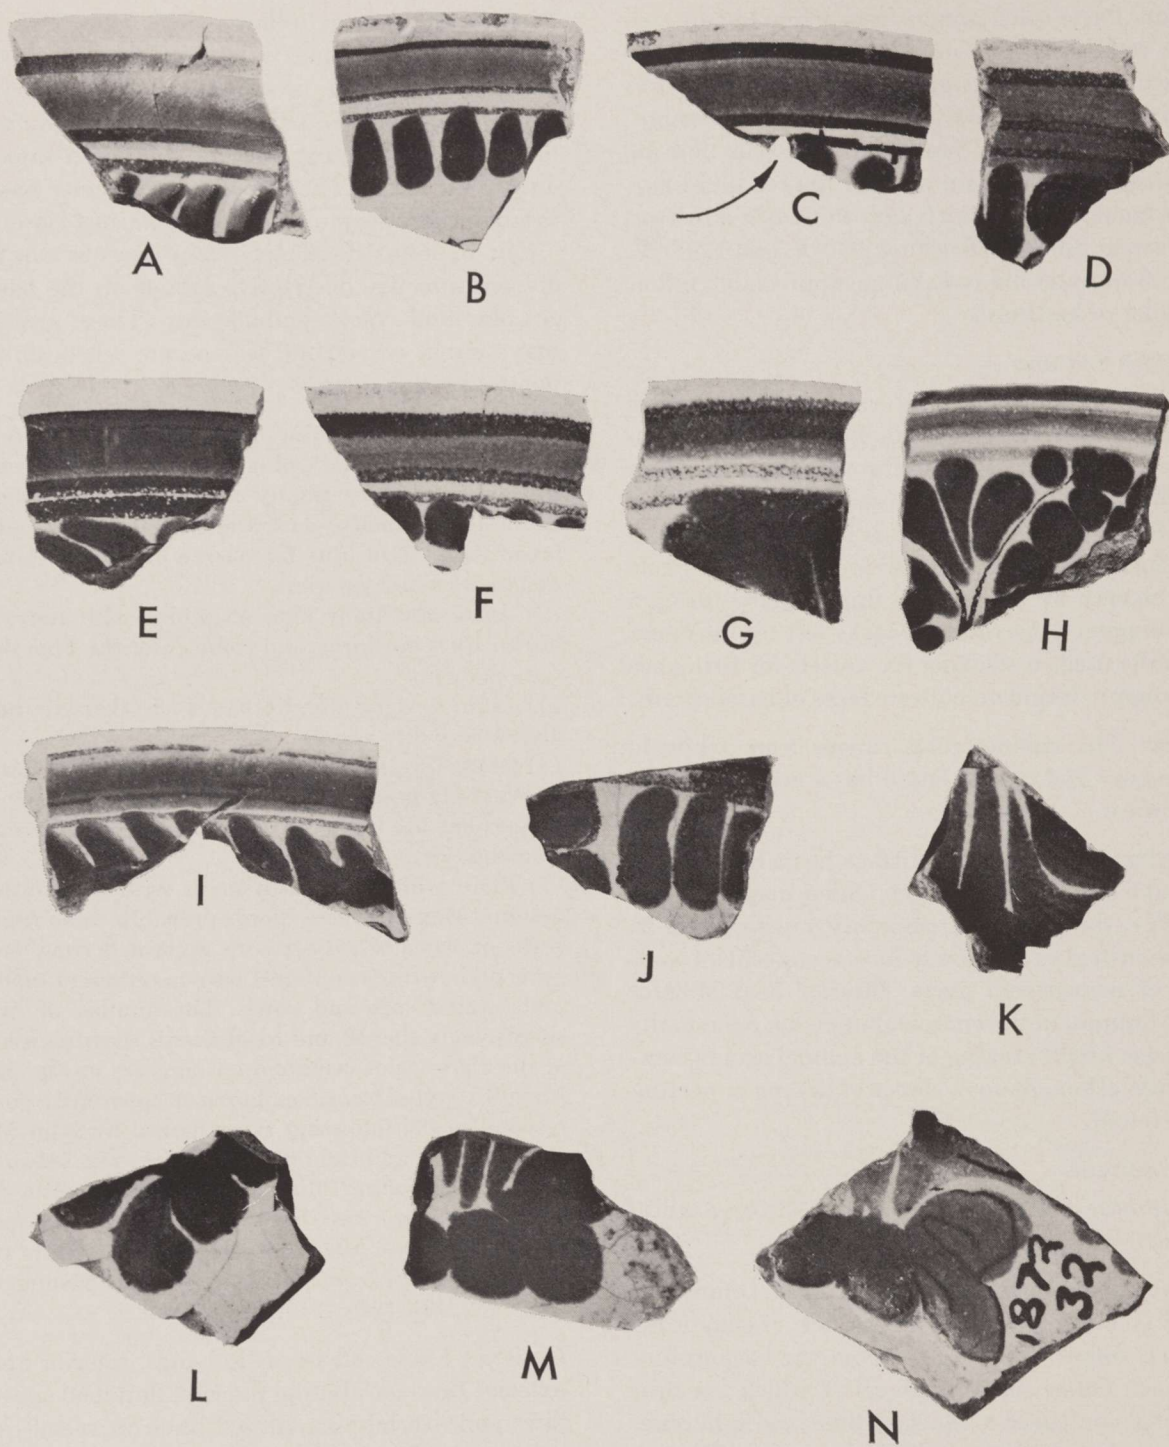
Fig. 47. Ceramics, glossy white majolica. A-I, blue and brown on white rim sherds; J-N, blue and brown on white body sherds. Note drilled hole in lower edge of C.

Designs: These consist of lip bands, interior and exterior lines paralleling the rim, flattened spiral lines and overlapping curved lines on vessel exteriors, and floral motifs on vessel interiors. The floral designs consist of rows of thick, rounded leaves, composite leaves, and blossoms. These elements occur in clusters, suspended from lines, arranged on brown stems, or free-floating on the white background. Zoomorphic elements are commonly found on majolica at other sites, but are extremely rare on sherds from San Lorenzo. The variety of rim designs is shown in Figs. 46,

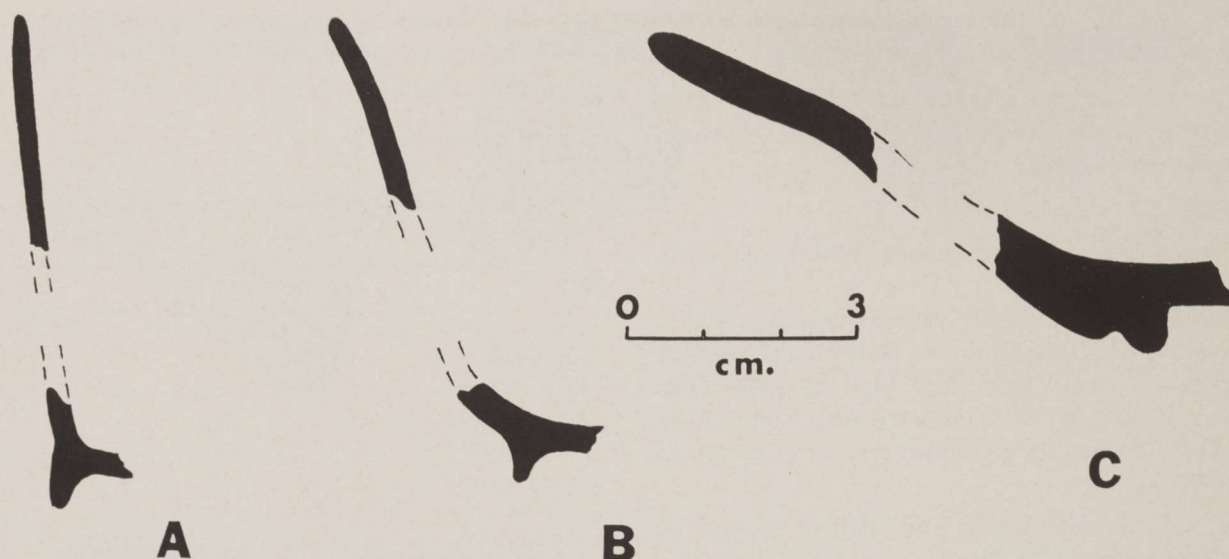
Fig. 54. Cross sections of majolica sherds. A, typical rim and base cross section of deep cup; B, typical rim and base cross section of deep bowl; C, typical rim and base cross section of deep plate.

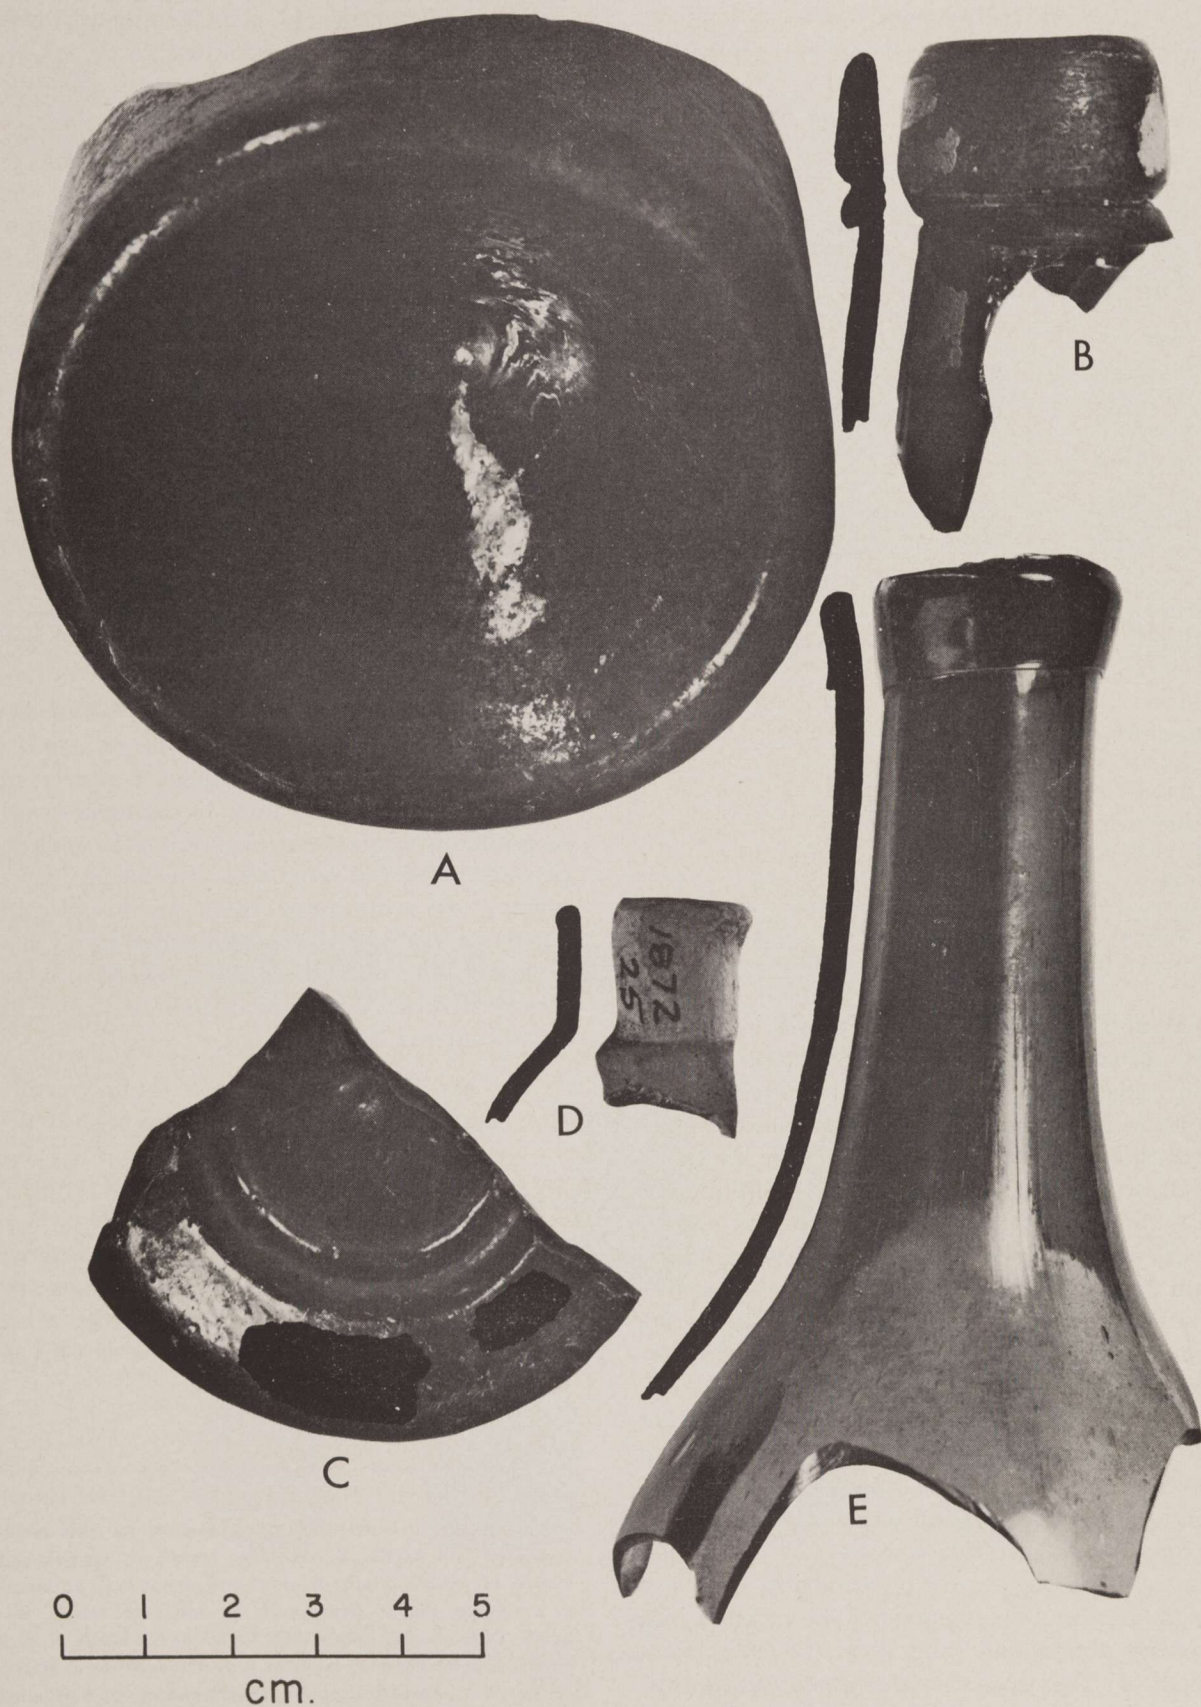
Fig. 58. Bottle fragments. A, base of dark green wine bottle; B, neck of dark green, mold-made whiskey bottle; C, base of dark green, mold-made whiskey bottle; D, neck of pale blue-green bottle; E, neck of pale green wine bottle.

(Fig. 58, E), 12 cm. long. Its smoothly sloping shoulder has a long, narrow neck tapered in slightly toward the lip, which is straight and smoothly finished. A narrow band of glass about 1.2 cm. wide and 2 mm. thick has been added around the exterior of the neck just below the lip. This reinforcing band is smoothly polished onto the bottle neck. The exterior diameter ranges from about 6 cm. on the slope of the shoulder to 2.9 cm. near the lip. There are no mold marks on this fragment.

A pale aquamarine is the color of these transparent sherds, containing a few tiny, spherical bubbles. All sherds are heavily coated with a dull white, chalky patina and all are from small bottles (Fig. 58, D), with no mold marks visible. Thickness ranges from 1 mm. to 6 mm., and is variable on each sherd. The only large sherd is a

These sherds are of recent origin and a variety of colors: white, dark brown, dark green, colorless. Some have trade names such as "Lea & Perrins." One molded dark green whiskey bottle (21 sherds), with a hand-finished neck, (Fig. 58, B and C) was found in a disturbed area on the floor of Structure 8. This bottle probably dates to the Camp Wood occupation in the mid-nineteenth century.

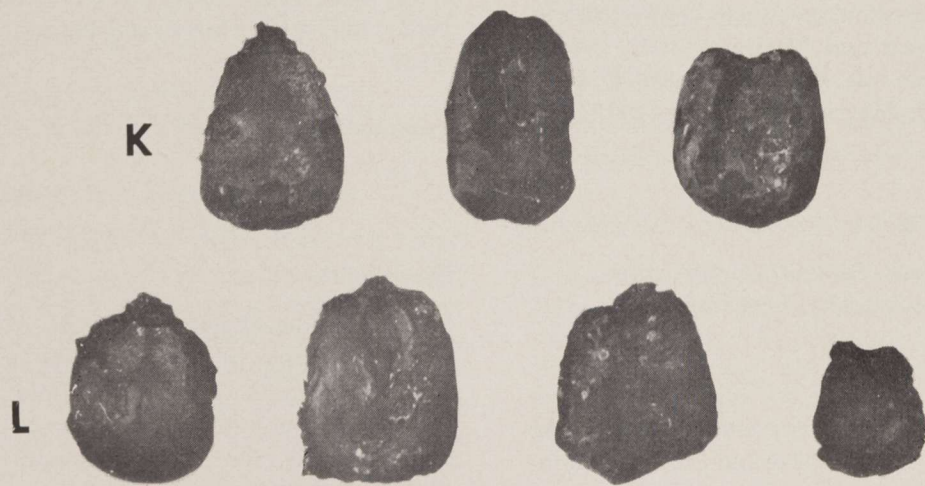
Fig. 60. Glass beads and plant remains. A, medium-size compound red beads; B, alabaster beads; C, medium-size, simple, blue-green beads; D, small-size compound, red beads; E, small-size, simple, clear beads; F, small-size, simple, blue beads; G, small-size, simple, dark burgundy red beads; H, coral beads; I, pearl bead; J, seeds of a prickly pear cactus (*Opuntia* sp.); K, L, charred corn grains from Structure 10; A-H, upper scale; J-L, lower scale.

Along the base of the south wall, about 10 feet from the west wall, there was a crack about 0.1 foot wide, 2 feet long, and 0.5 foot deep between the plaster and the brick wall. This cavity was completely filled with grains of shelled corn (Fig. 60) which had apparently fallen through cracks in the plaster and were charred when the building burned. Dr. Hugh Cutler of the Missouri Botanical Gardens furnished the following comments on the charred corn grains found in Structure 10:

MEDIUM-SIZE, COMPOUND, RED BEADS (Fig. 60, A), 29 specimens

Composed of four layers: (1) a thin (about 0.2 mm.) outer layer of translucent pale green glass with no visible bubbles; (2) two identical superimposed, opaque red layers (sometimes appearing to be a single layer), each about 0.1 mm. thick and seeming to contain no bubbles; (3) a translucent pale green core layer averaging about 1.4 mm. in thickness and containing chains or lines of tiny bubbles running parallel to the hole. The green layers are probably the same type of glass used in making eighteenth century pale green wine bottles. A gold or copper-derived pigment was frequently used to produce bright red glass (Lardner, 1832: 210–215). The red glass in these beads probably contains one of these expensive pigments, and the use of very thin layers of red over a thick green core enabled the makers to produce a brilliant red bead with a minimal expenditure of the red pigment.

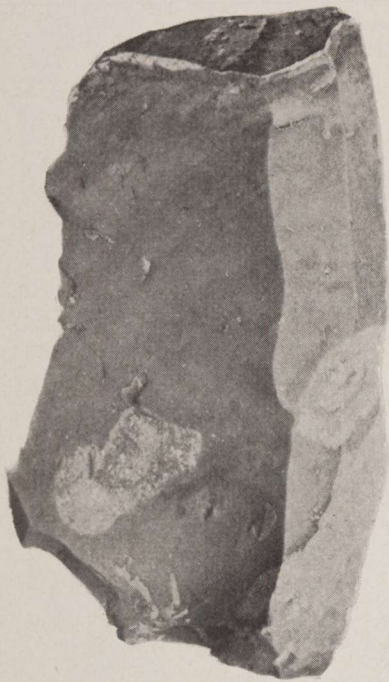
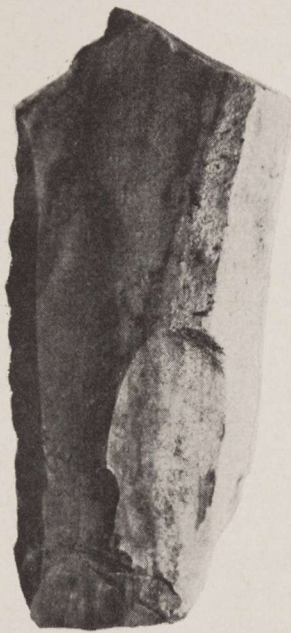
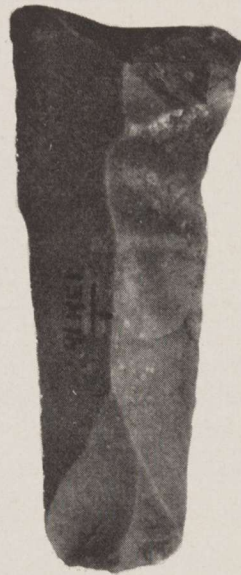
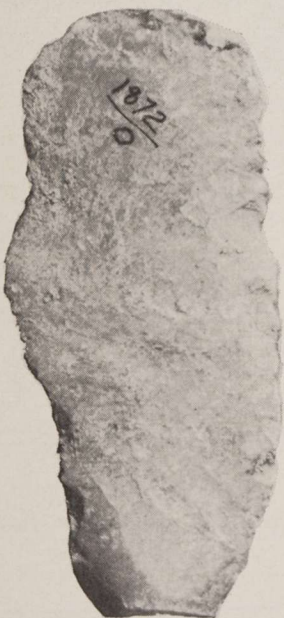
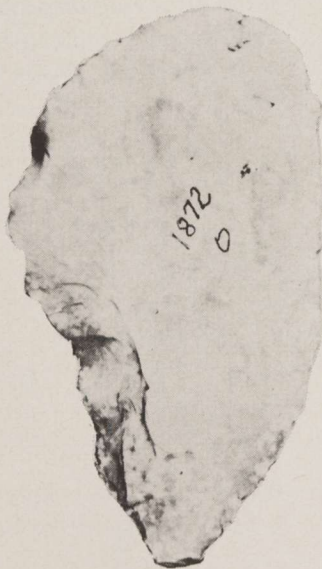
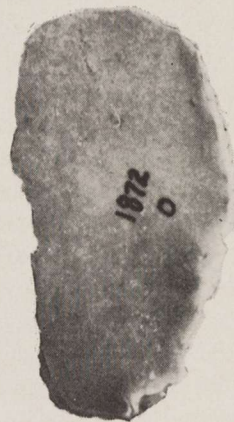
Fig. 65. Stone artifacts. A–D, long, narrow flakes, Type 1; E–H, small triangular arrow points; I, Perdiz arrow point; J–M, blade scrapers; E–I, upper scale; A–D and J–M, lower scale.

Type 1 (19 specimens) are long, narrow blades with the removal flake scar forming the ventral face and from one to five long, parallel flake scars of previously removed blades forming the dorsal surface (Fig. 65, A–D, and Fig. 69, B, C, E). Only three were removed from a core with a cortex-covered striking platform—the remainder have remnants of freshly prepared striking platforms. Two broke away from the core with a hinge fracture on the end opposite the source of the removal blow, and the remainder broke straight out of the core and have a feathered end opposite the striking platform and bulb of percussion. In general outline the flakes are roughly rectangular with the striking platform forming one end. The maximum width of the flakes occurs at the striking platform end of three specimens, at the end opposite the striking platform of three specimens, and more toward the center of the remaining blades. Flakes of this type were used for fashioning the blade scrapers and blade knife described above and probably served as a source of Type 2 and 3 gunflints. Measurements of more complete specimens are shown below.

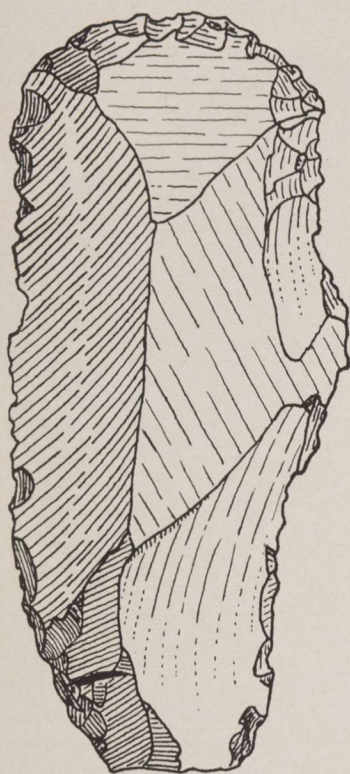
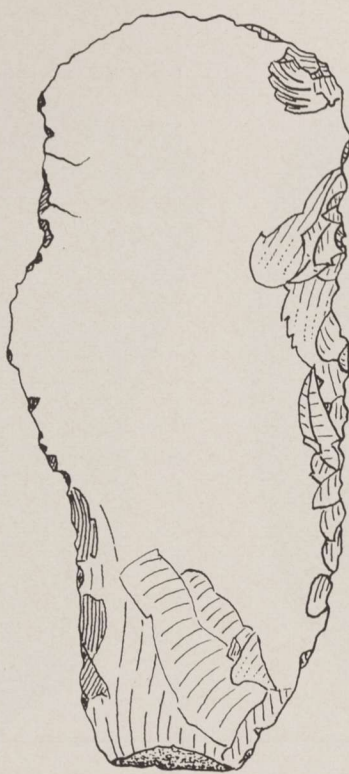
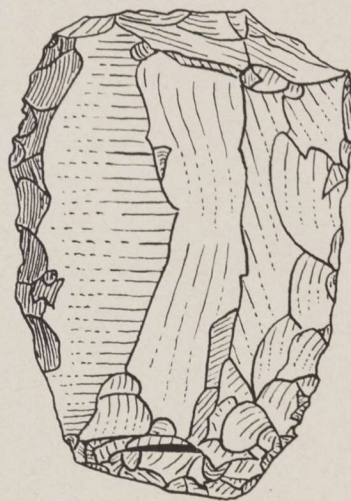
Fig. 66. Stone artifacts. A–D, blade scrapers.

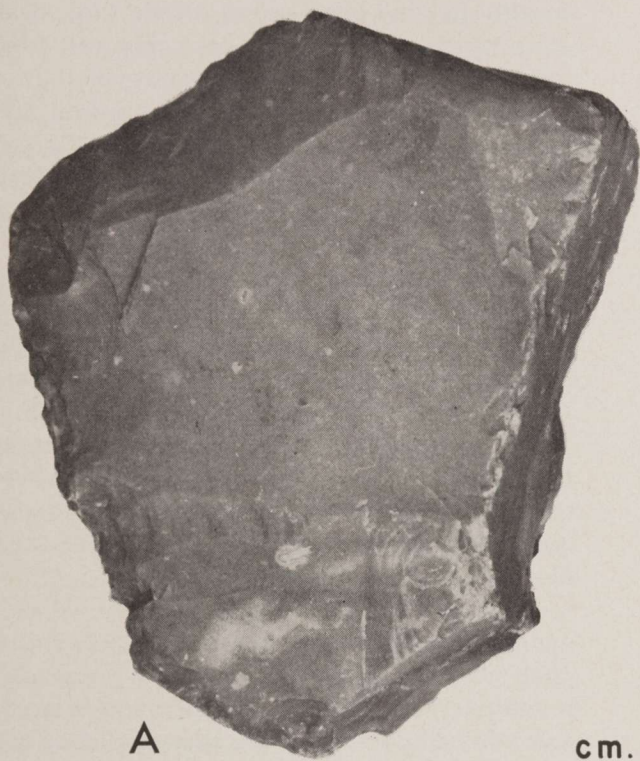
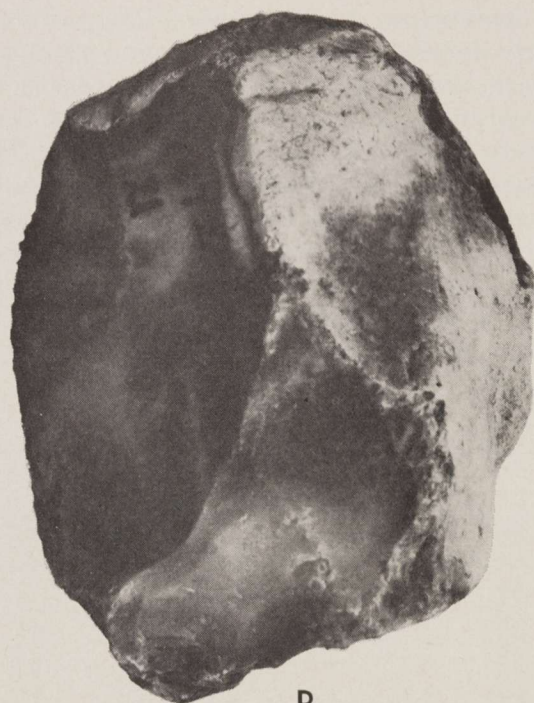
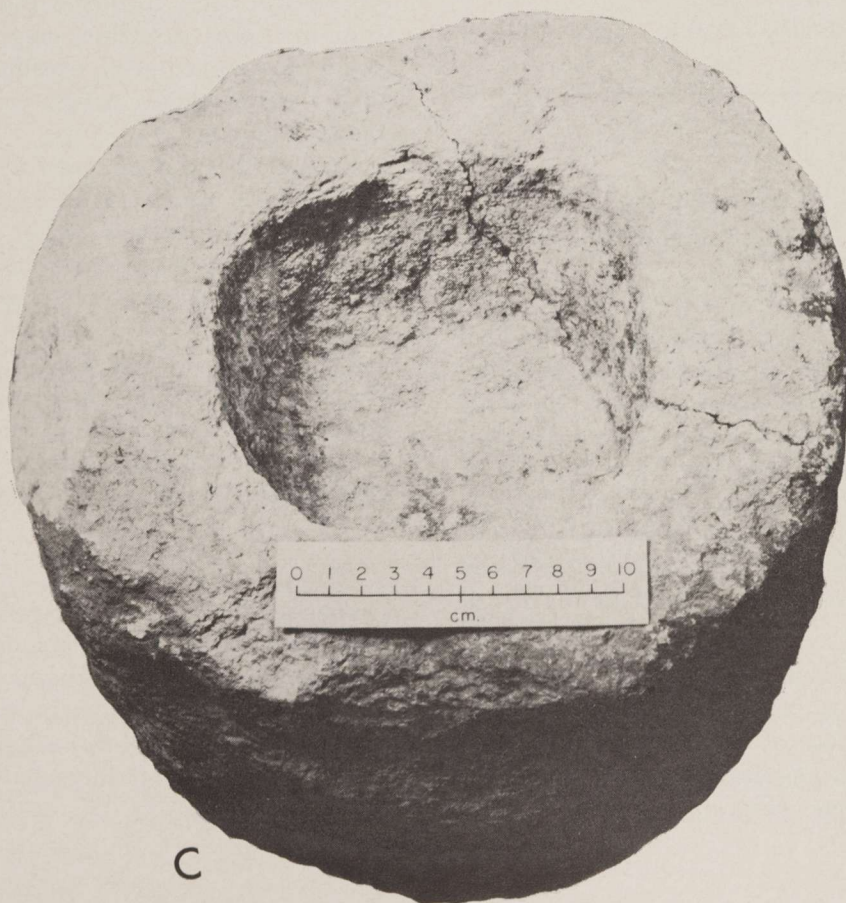
Fig 67. Stone artifacts. A, B, large choppers; C, limestone socket for door post.

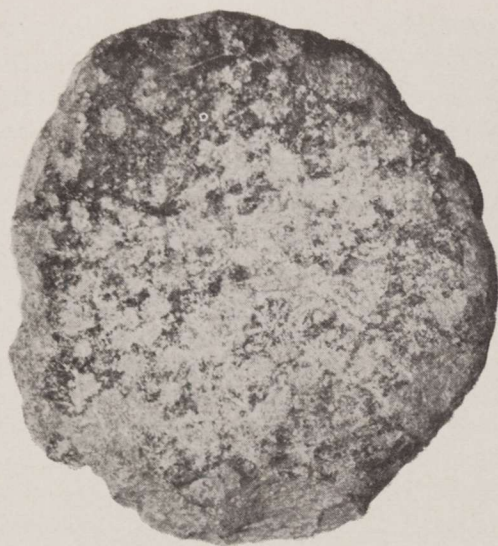
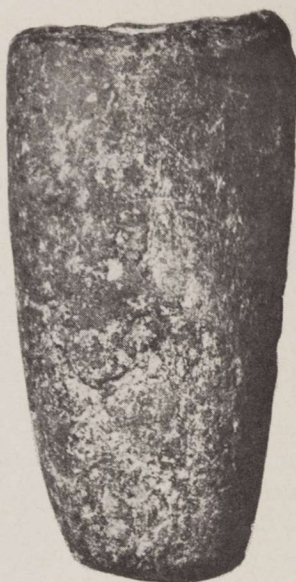
Fig. 69. Stone artifacts. A, D, large cores with prepared striking platforms; B, C, and E, flakes, Type 1.

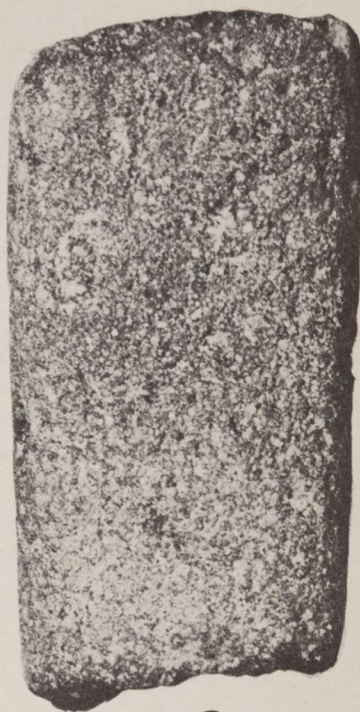
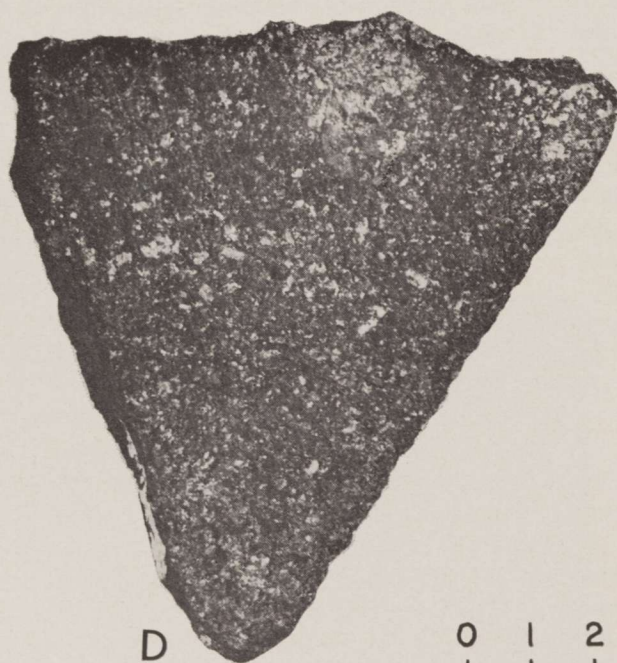
Fig. 70. Ground stone artifacts. A, round flat disc; B, end of circular cylindrical mano; C, end of rectangular mano; D, edge of flat metate; E, tubular stone pipe. Specimens B-E are made of igneous rock not found in the Nueces canyon.

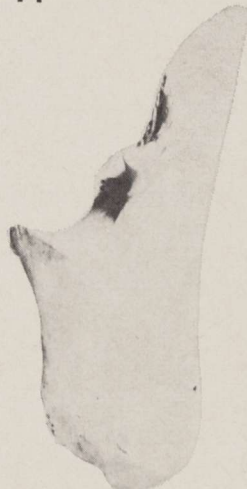
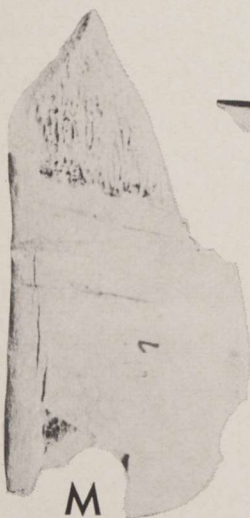
Four deer ulnae show signs of use, probably as awls or pressure flaking tools. The distal tips of all four specimens have been broken (Fig. 72, K, L), but around the broken edge on each there are scratches and striations. The proximal ends are unaltered. Because of their convenient size and shape, deer ulnae have been commonly utilized by Indians and are frequently reported at prehistoric sites in Central and West Texas. One specimen was found on the floor of Structure 8, one on the floor of Structure 14, one in the mission midden, and the other on the disturbed surface of the site.

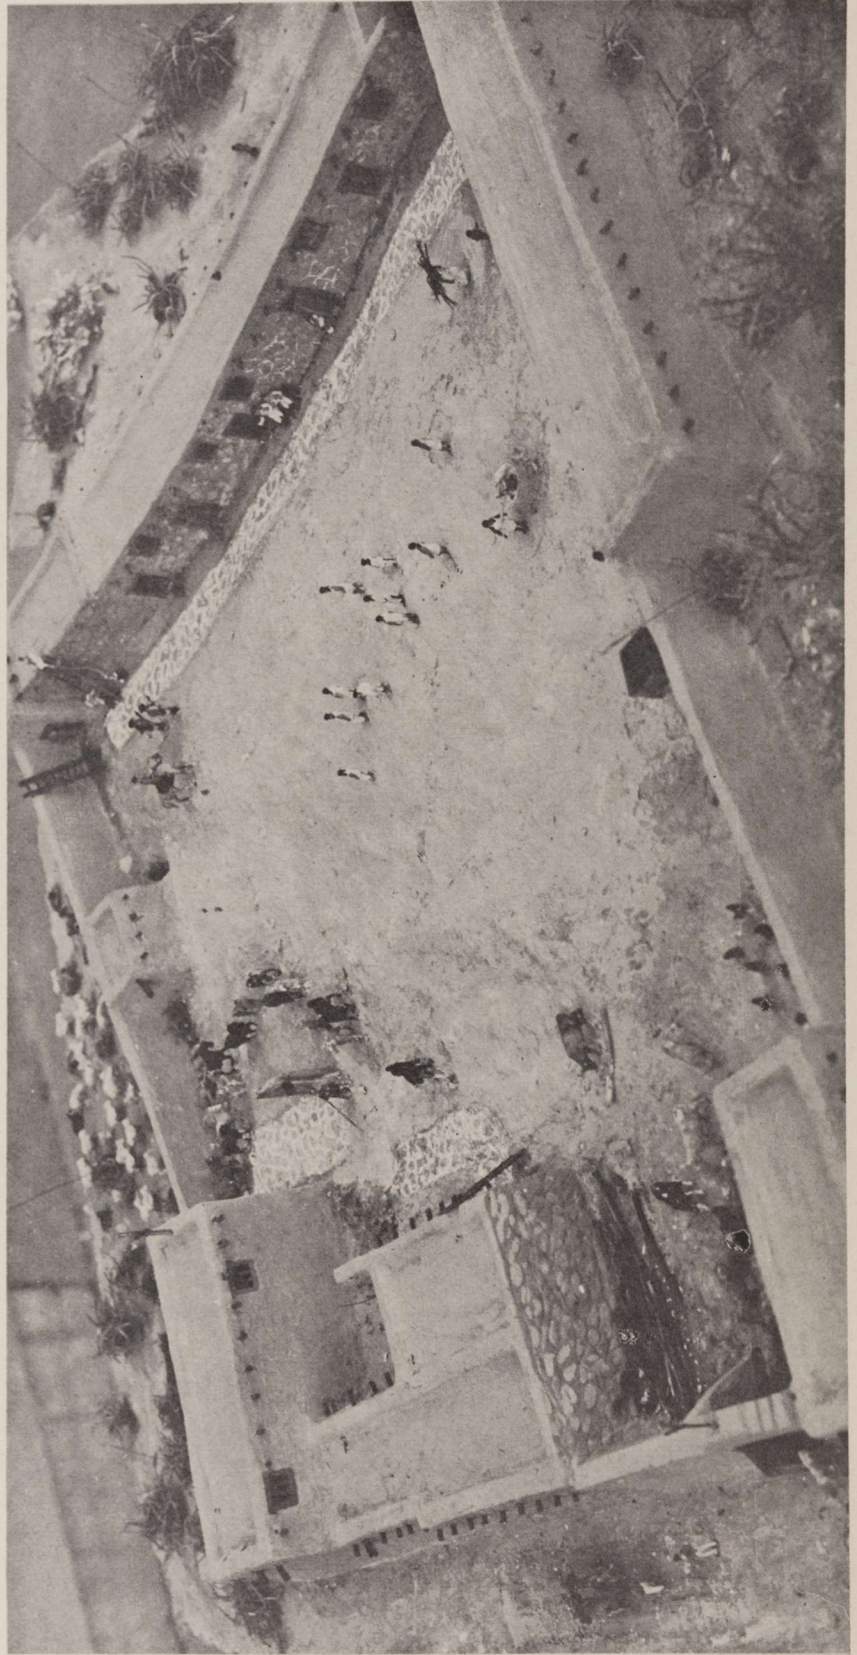
Fig. 74.—Scale model of Mission San Lorenzo, Texas Memorial Museum. Top, view of model looking north. Bottom, view of model looking down and toward the southwest.
